INNISFIL CREEK SUBWATERSHED

Health Check 2023

Nottawasaga Valley
Conservation Authority

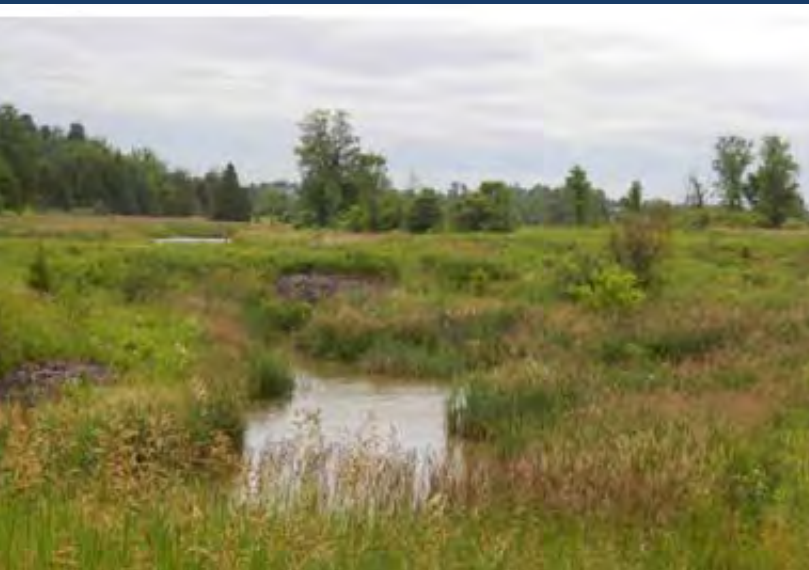
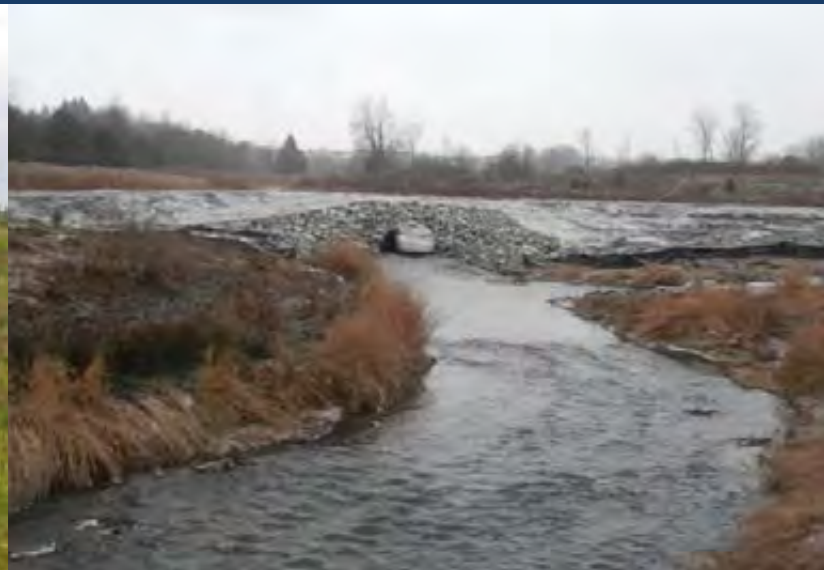
Before (2017)

After (2018)

An example of stream restoration in the Innisfil subwatershed:

A retrofitted failed ice dam structure completed to reestablish a fish migratory route and maintain cool water in Beeton Creek.

1. Improve stream health and fish habitat by continuing to complete floodplain construction, stream bank stabilization with a habitat-friendly approach, livestock exclusion fencing and stream-side tree planting on Beeton Creek between the 7th Line New Tecumseth and the Bailey Creek confluence located north of the 10th Line.
